Tack Coat Effect on Field Performance

December 2, 2014
Wisconsin Asphalt Paving Association
Madison, WI

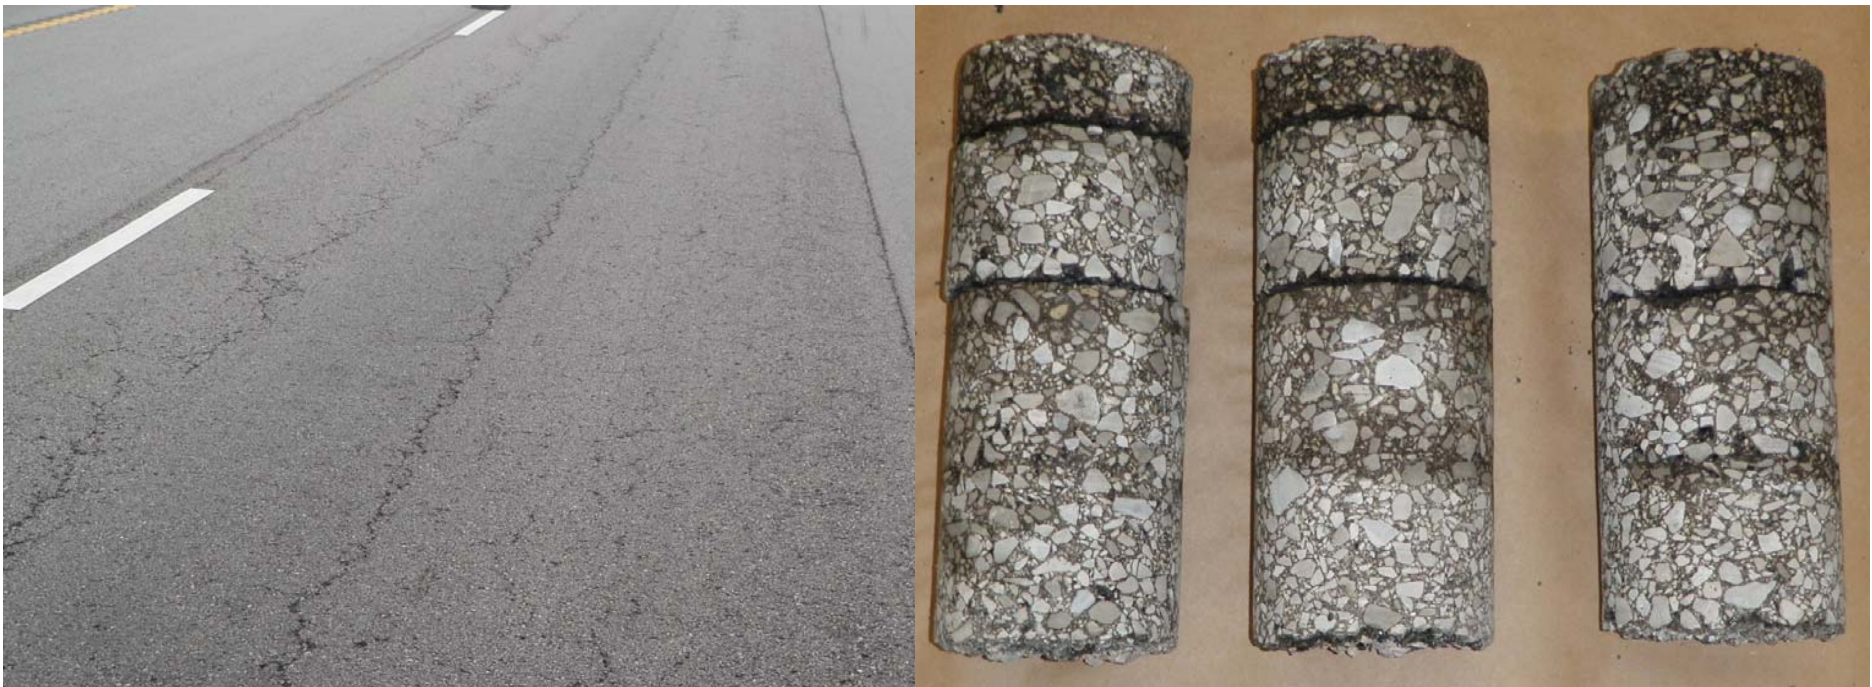
You might have a bonding problem if ...

- Longitudinal cracking near the wheel path

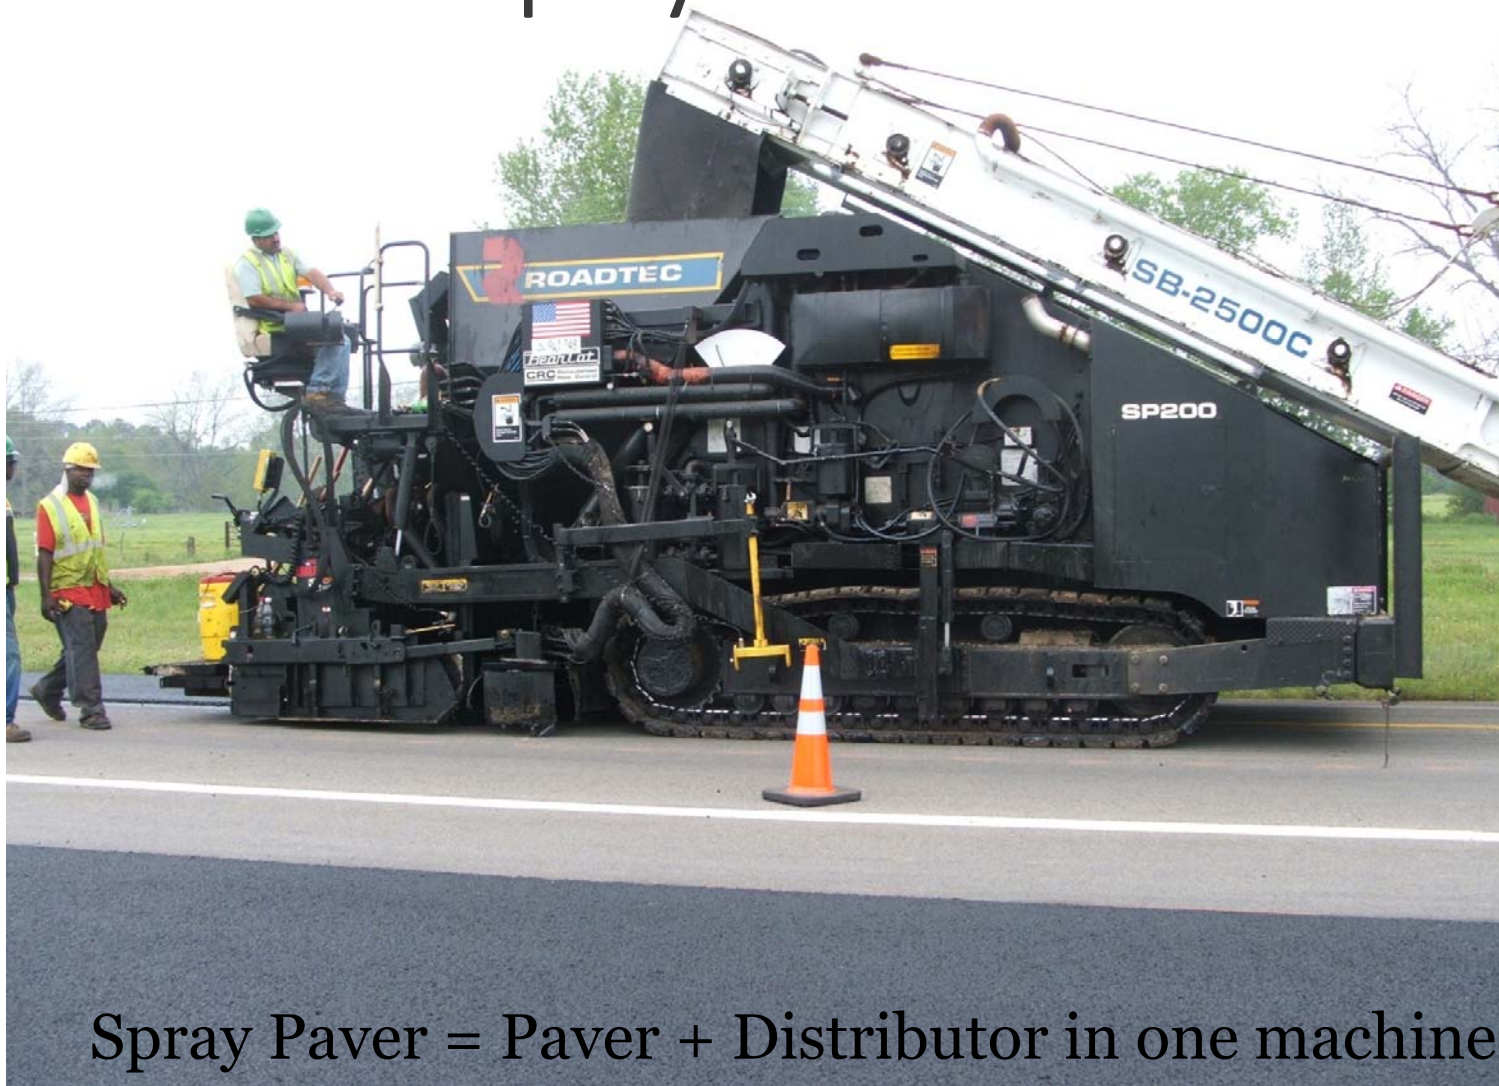
What is a Spray Paver?

Spray Paver = Paver + Distributor in one machine

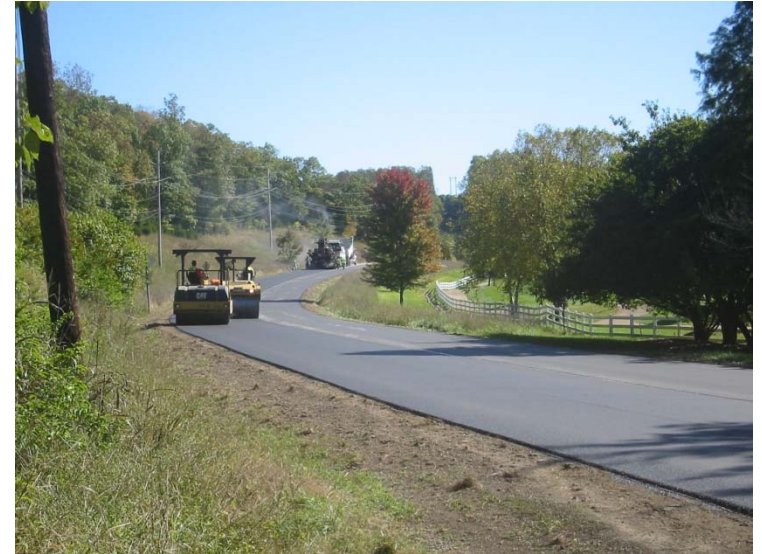
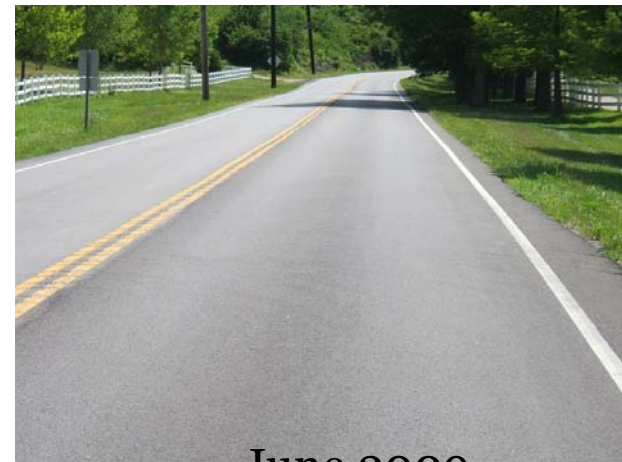
Route T, Franklin County, MO

- Constructed: October 2008
- Contractor: N.B. West
- Project length: 3.5 miles (test sections)
- Surface: Composite, HMA over PCC
- Mix: 1 ¾" Bonded BP-1 HMA w/ PG64-22
- Tack:
 - Test sections at 0.1, 0.15, and 0.2 gal/yd² PMAE at 65% AC
 - Test sections at 0.1 gal/yd² thru distributor and 0.1 and 0.15 gal/yd² CSS-1h thru SP-200
- Equipment: RoadTec SP-200 spray paver

June 2009

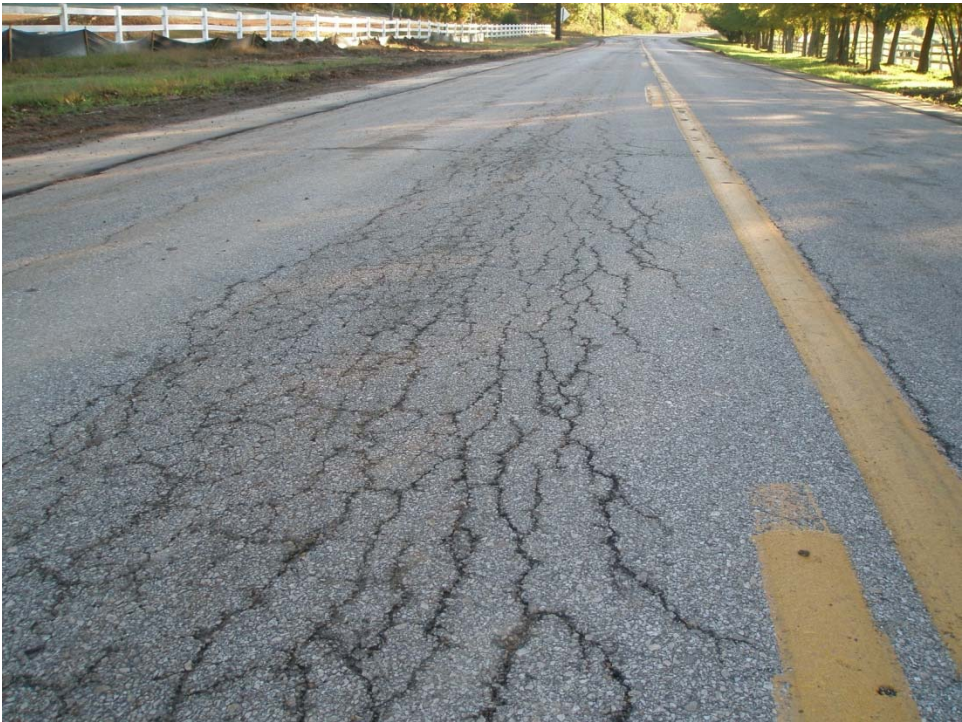
Route T Franklin Co Test Sections 11/12 Pre-paving and 4 years later

0.21 gal/yd² (0.14 res) PMAE Tack

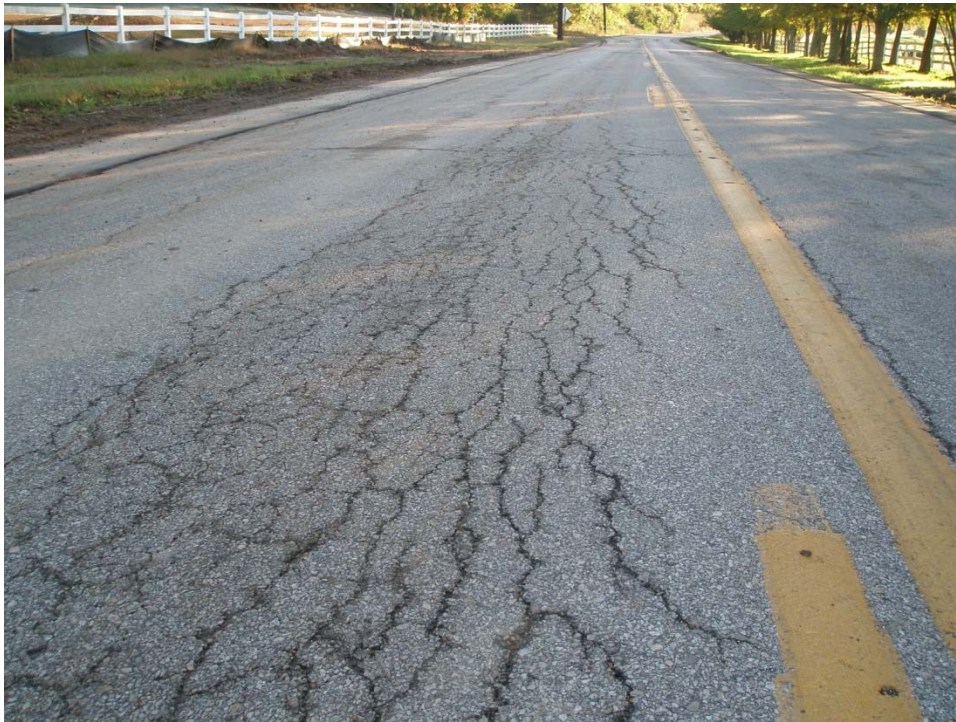
Route T Franklin Co Test Sections 11/12 Pre-paving and 6 years later

0.21 gal/yd² (0.14 res) PMAE Tack

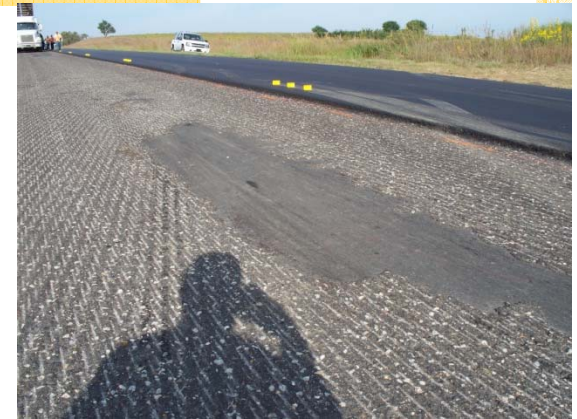
KDOT US 36 Washington Co. Project – Sept 2009 1 1/2" SR-12.5A over a Milled Surface

Test Section 11 40% RAP 0.35 gal/yd ² EBL	Test Section 10 40% RAP 0.25 gal/yd ² EBL	Test Section 9 25% RAP 0.12 gal/yd ² EBL	Test Section 7 25% RAP 0.20 gal/yd ² EBL	Test Section 5 25% RAP 0.16 gal/yd ² EBL	Test Section 3 25% RAP 0.08 gal/yd ² EBL	Test Section 1 25% RAP No Tack
		Test Section 8 25% RAP 0.12 gal/yd ² CSS-1h	Test Section 6 25% RAP 0.20 gal/yd ² CSS-1h	Test Section 4 25% RAP 0.16 gal/yd ² CSS-1h	Test Section 2 25% RAP 0.08 gal/yd ² CSS-1h

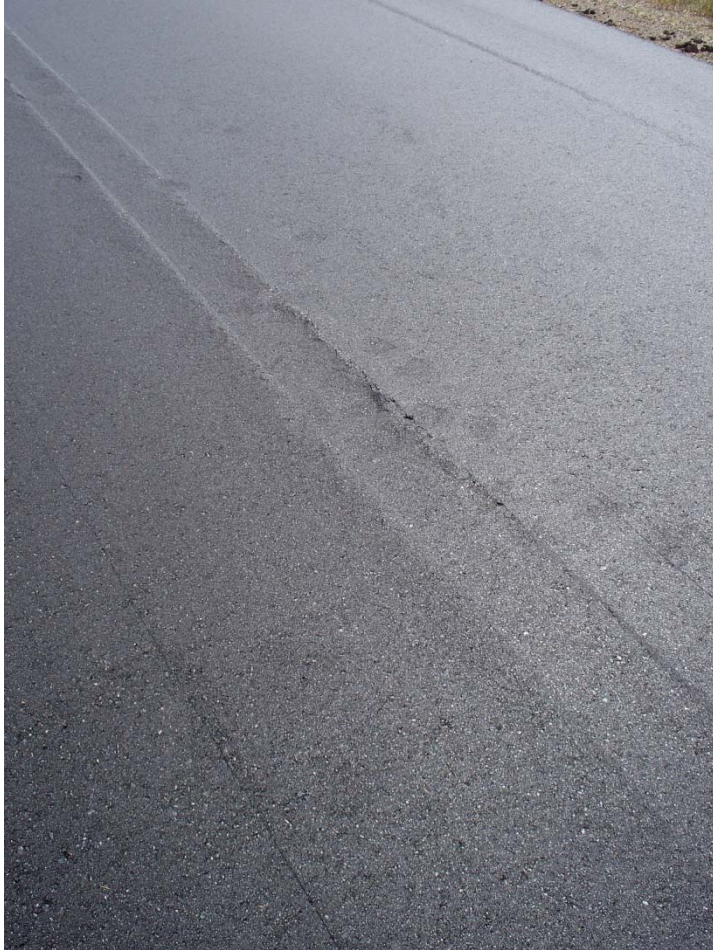
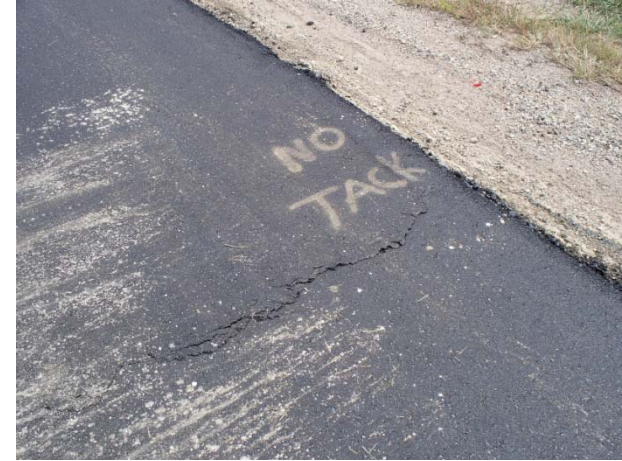
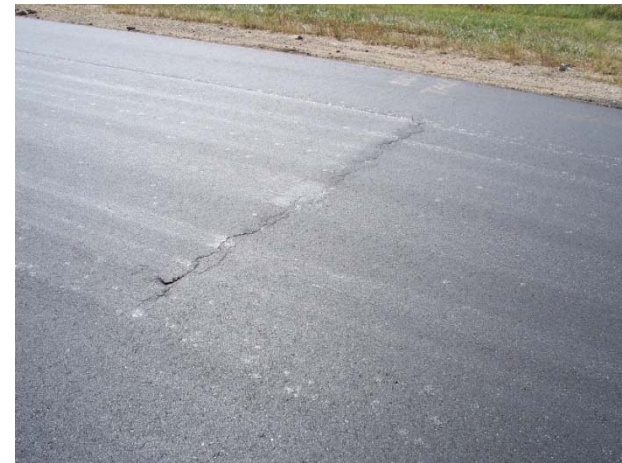
No Tack over a Milled Asphalt Surface US 36 Washington Co. KS 2009

No tack over a milled surface – 2 years later

- US 36 Washington County, KS
- Fatigue cracking in the inside wheel path
- Effect of unbonded overlay

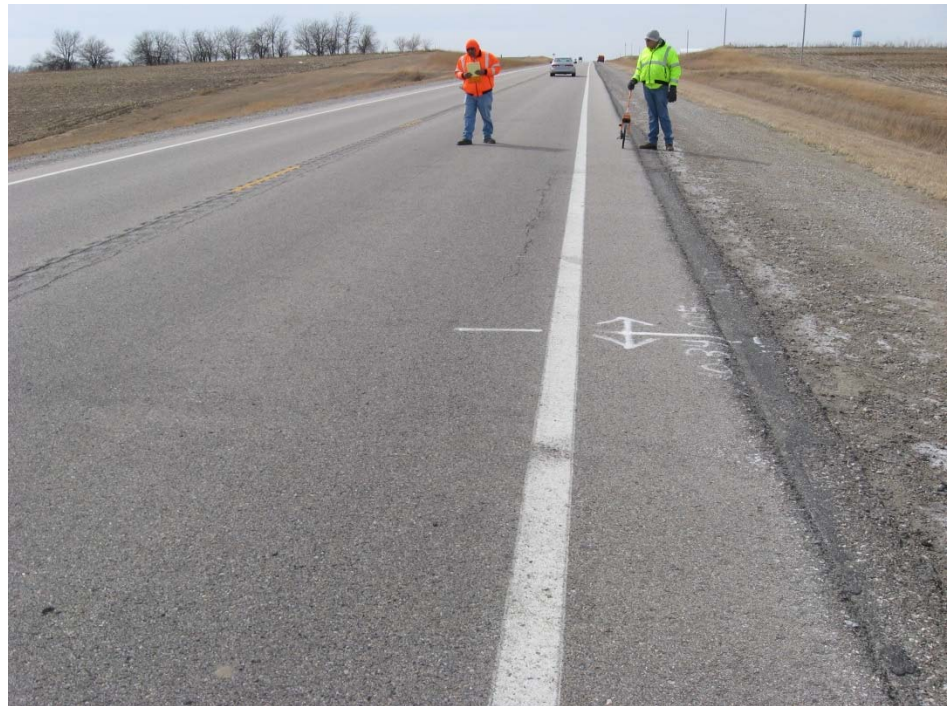
KDOT US 36 Nemaha County 2010

- 4" CIR with emulsion
- 1 ½" SR12.5A
- PG70-22 binder
- 4 Test sections
 - 3 spray paver shot rates
 - 0.11 gal/yd² EBL
 - 0.22 gal/yd² EBL
 - 0.34 gal/yd² EBL
 - 1 distributor applied control section
 - 0.05 gal/yd² CSS-1h

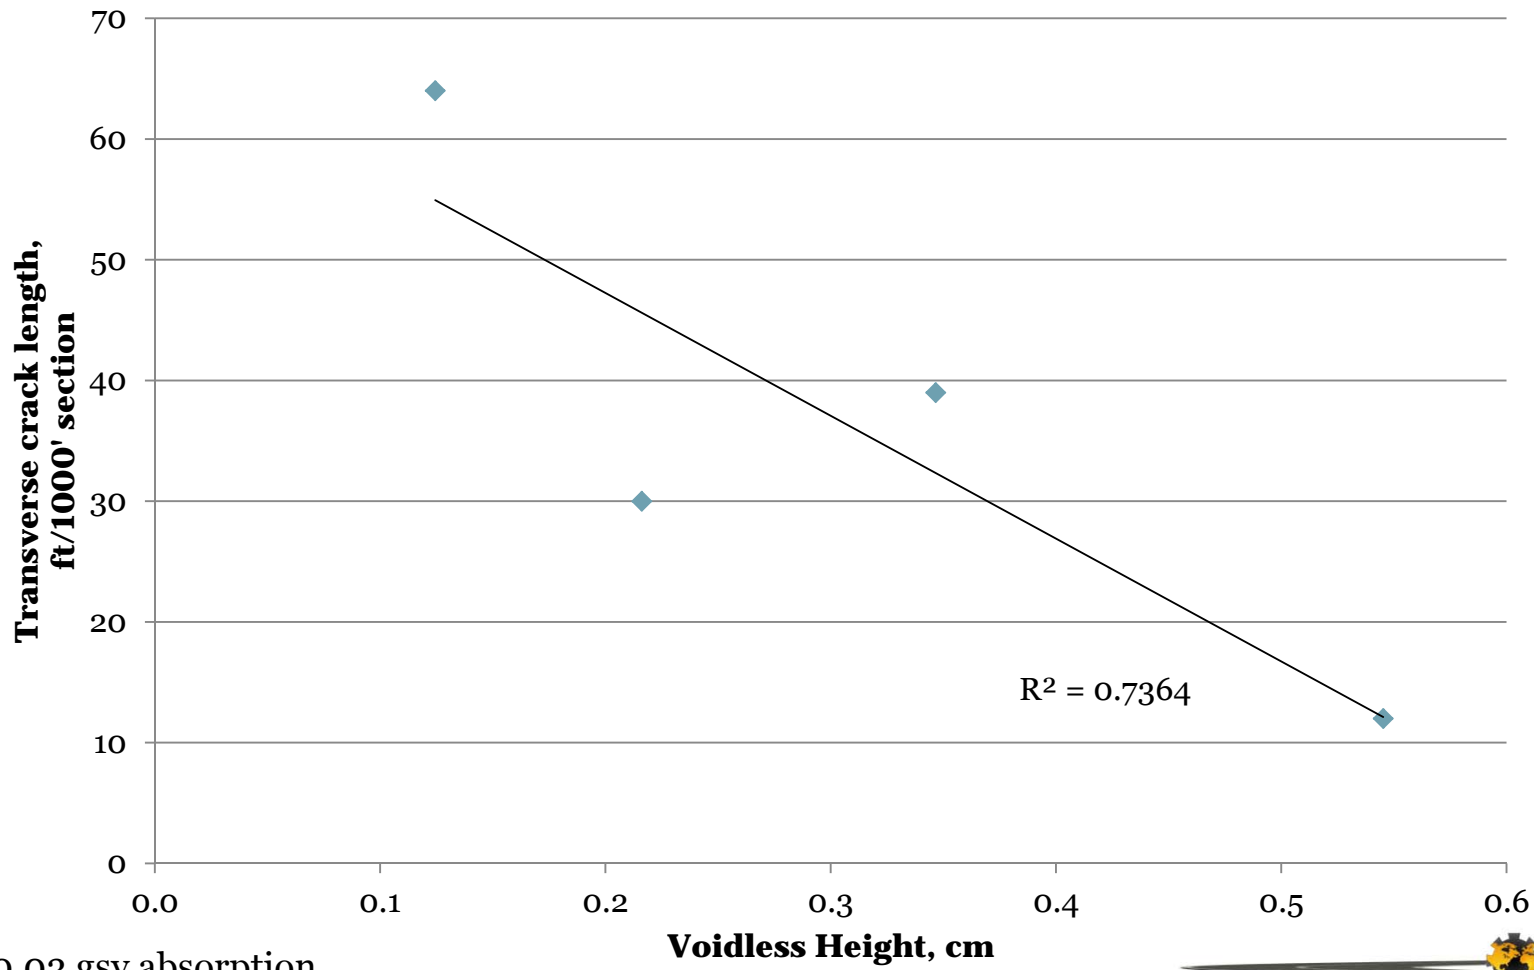
KDOT US 36 Washington Co at 31 months Transverse Cracks vs Voidless Height All CSS-1h sections

*Assumes 0.03 gsy absorption

- Based on field project data,
 - Correlation of bond energy to longitudinal cracking resistance exists
 - Correlation of voidless height to transverse cracking exists
 - General trends favor higher application rates (than standard tack rates) and polymer modified tack
 - Improved mix performance; more resistance to transverse and longitudinal cracking
 - Field data from more projects are being gathered
